**Монтаж ондутина А100 на скатных крышиах**

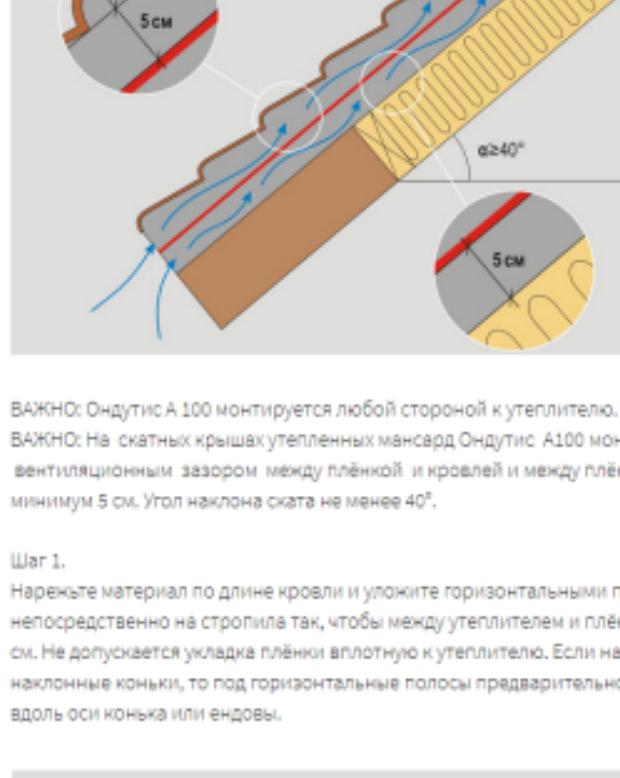
The diagram illustrates a cross-section of a roof. It features a yellow triangular gable end at the top right. The roof deck is shown as grey rectangular panels. A thick layer of grey insulation is applied horizontally across the roof deck. Red diagonal hatching indicates vertical insulation panels, which are visible along the eaves and under the gable. A small white window is positioned in the gable area.

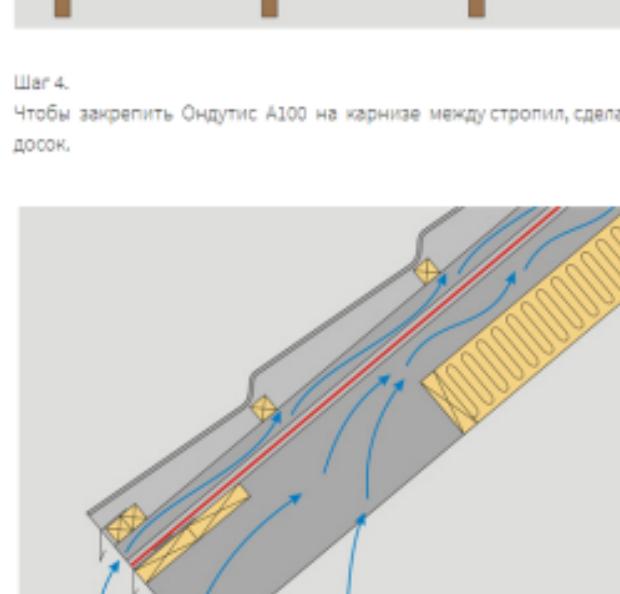
Шаг 5.  
Нижняя кромка Ондутис A100 закрепляется на капельнике вдоль крайней доски настила лентой Ондутис BL. На кровлях с водосточной трубами желоб расположен выше капельника, с зазором для свободного доступа воздуха под кровлю. Запрещается

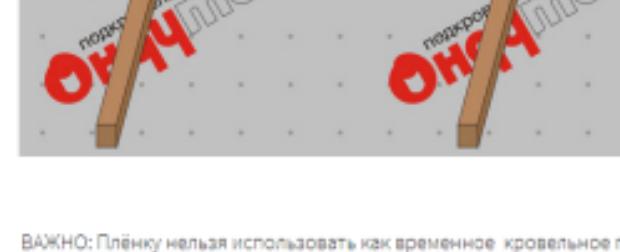
A schematic diagram of a two-stage compression system. It shows a vertical cylinder divided into two sections by a piston. The top section is labeled "Stage 1" and the bottom section is labeled "Stage 2". A large orange arrow on the left indicates air entering from the bottom and moving upwards through both stages. A smaller orange arrow on the right indicates air exiting from the top. The cylinder is mounted on a base with a fan-like pattern.
